First Look Report

First Look Report for FBC Gowensville - - 16

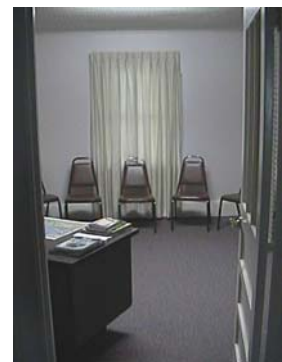
Room # 2 Name = office Division = Adult

Overall Condition A

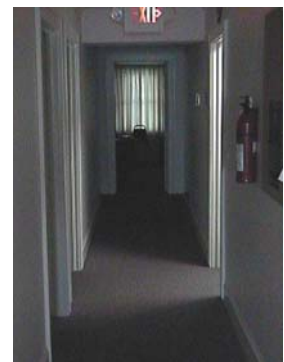
1. Overall the condition is very good. The new carpet and paint create a sense of pride in the building.
2. The tack boards displaying children's work is very nice. There is the room to add another board on each of the same walls.

1. Direction signs to Sanctuary and restrooms. Also signs on both sides of hallway doors informing guests what classes meet in those areas.
2. Classroom signs. Most of the classrooms have no indication who meets in them. For members that may be okay but for guests that do not know where they are going it is not acceptable.
3. Adding a second fire extinguisher on the opposite side of the hallway since there is a division of the hallway with the doors.
